### Ugly Tanker

#### Before and After Tanker Refurbishment

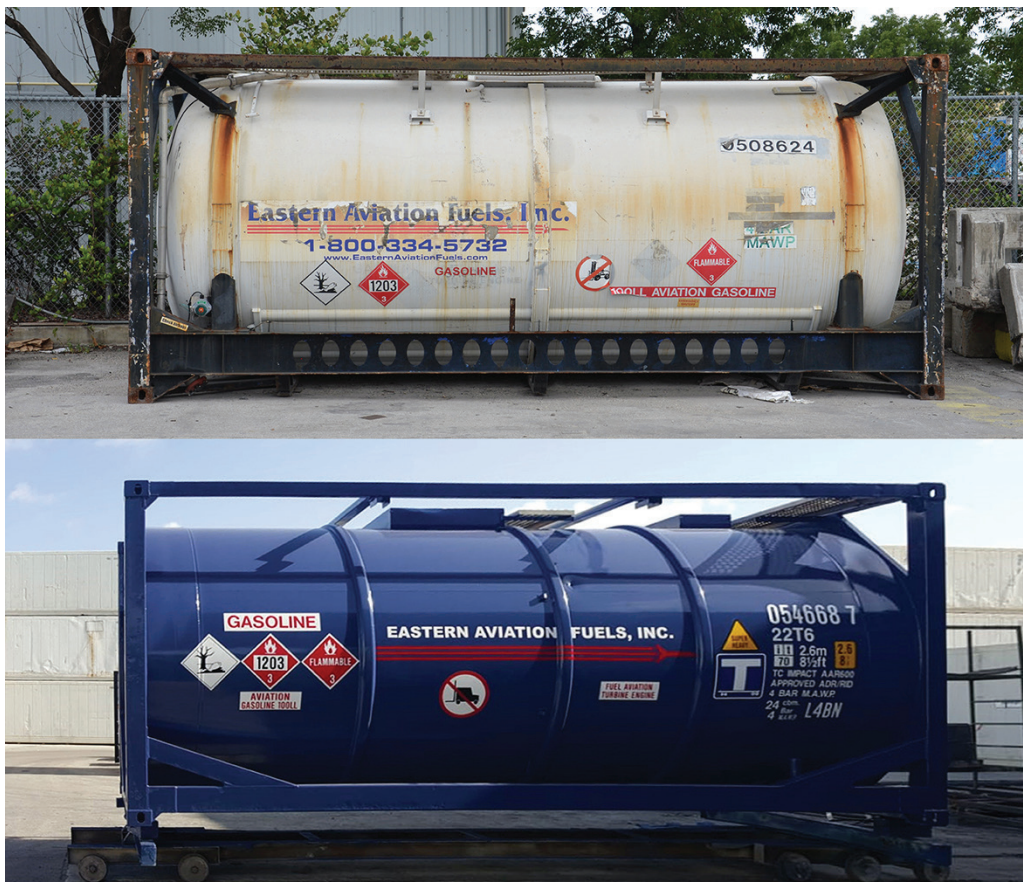
These 6,200-gallon tank containers were destined for the Caribbean but before they could be loaded with aviation fuel they needed GEM 360 to recondition them. Because of the salt water exposure this tank would be exposed to in its new home, it needed the specialized care that GEM 360 is well known for in the industry.

The tank was first water jet blasted to remove rust, old paint, and scaling. Next, it was sanded, given a coat of primer and coated with high-quality paint especially used for tank containers. The final step was installing their graphics. A true 360-degree exterior makeover!
